Title Don Williams Lake Spillway Fish Barrier

Course Name CEE:4850:0001
Senior Design

Fish Barrier at Don Williams Lake Spillway

Project Design Report – December 2018

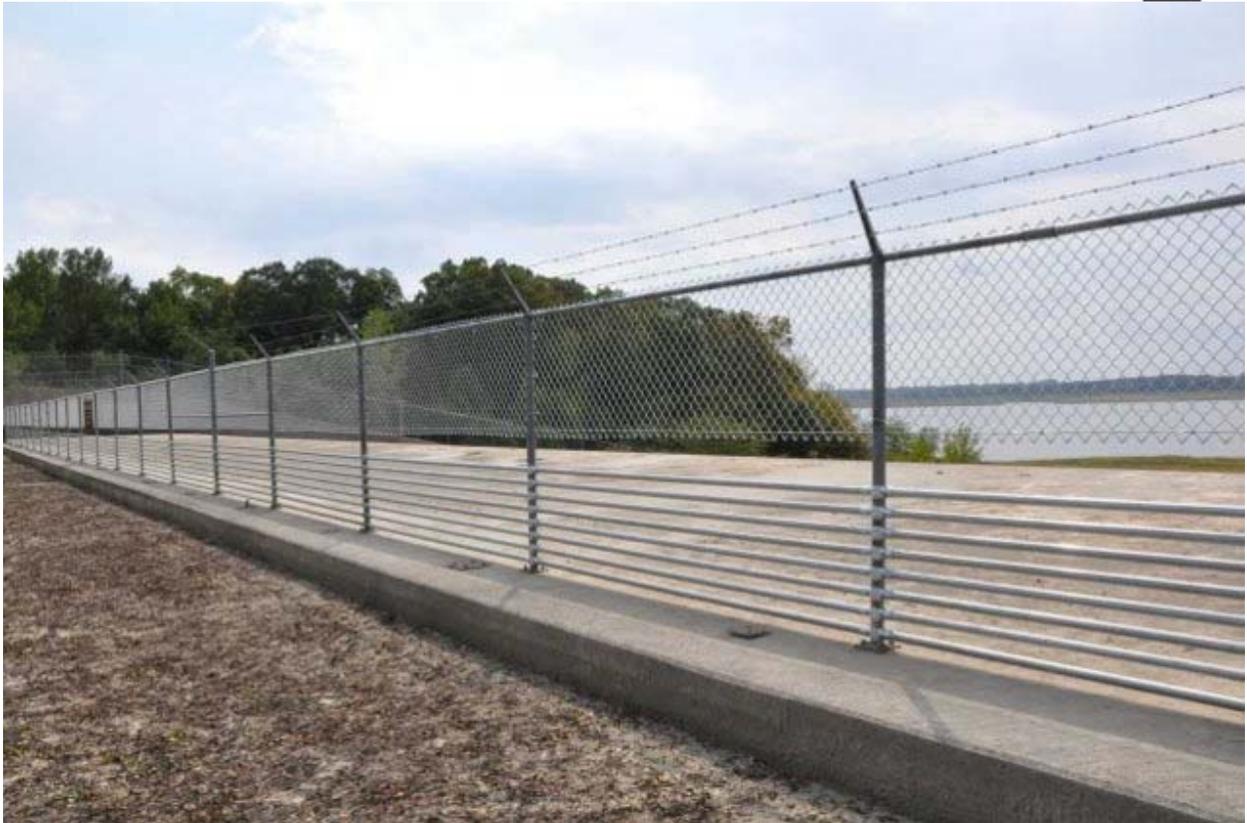
Figure 1 – Fence-Type Barrier

Alternative 1 used strategically spaced horizontal members as a barrier to prevent fish from escaping over the spillway. The barrier is to be mounted to the lake-side of the existing spillway structure. Horizontal members are to be secured with narrow vertical spacing to allow water to flow without significant resistance. The vertical spacing is specified to prevent smaller fish from escaping over the spillway. This alternative also includes a maintenance walkway to accommodate debris removal or member replacement as needed. Boone County Conservation Board suggests that large debris is not typical, however occasionally a large branch or other debris has been observed at the spillway. Alternative 1 includes lower barrier prevent invasive species from traveling up the spillway and into the lake. In years, past, Don Williams Lake has become overpopulated with gizzard shad. Gizzard shad have invaded Don Williams Lake from the receiving stream from the spillway and consume much of the available food needed for panfish to thrive. Additionally, a security fence will be installed to prevent visitors from accessing the walkway and barrier. This alternative has advantages and disadvantages as listed. An example of a fence-type barrier can be seen below in Figure 1.

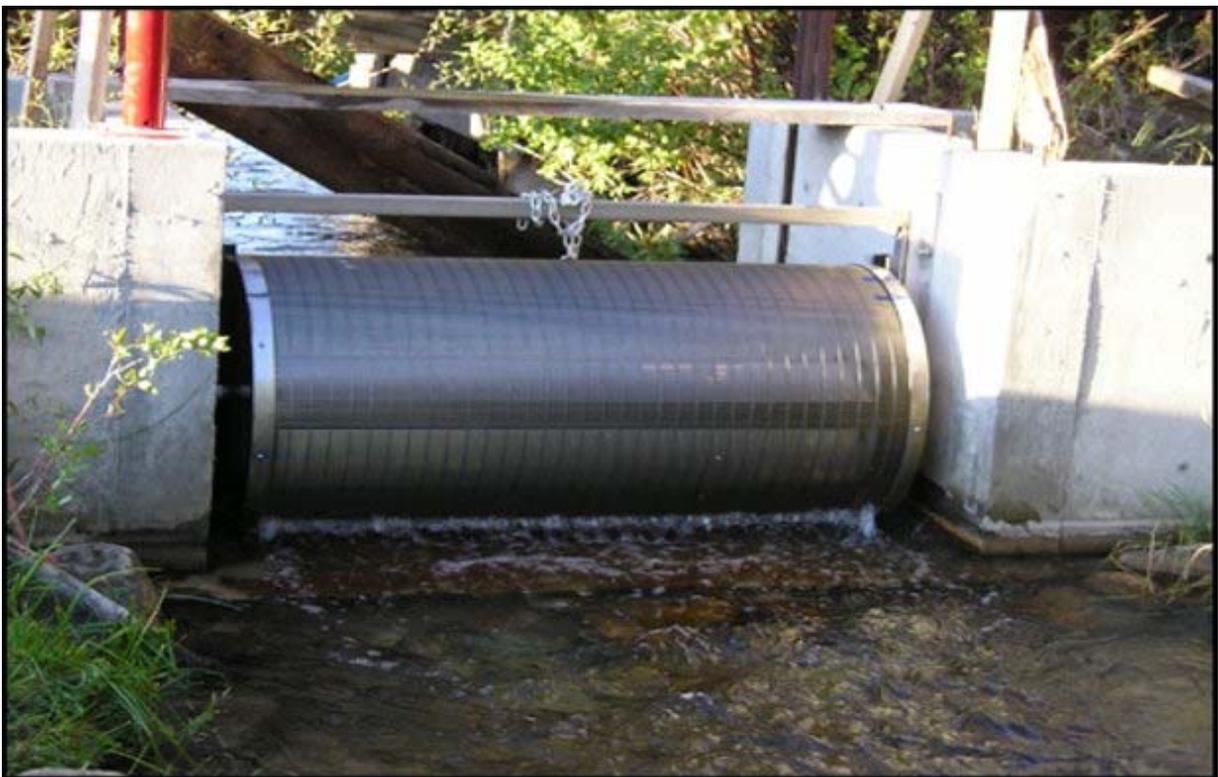
Figure 2 – Rotating Drum Screen

In Alternative 2, the fish barrier is constructed of a series of rotating drum screens. The screens are to be constructed to continually rotate at the top of the spillway when water level is any amount above spillway elevation. The rotating drum screens are “self-cleaning” of debris, to reduce maintenance. Similar to Alternative 1, this alternative includes a maintenance walkway and security fence. This alternative has advantages and disadvantages as listed below. An example of a rotating drum screen can be seen below in Figure 2.

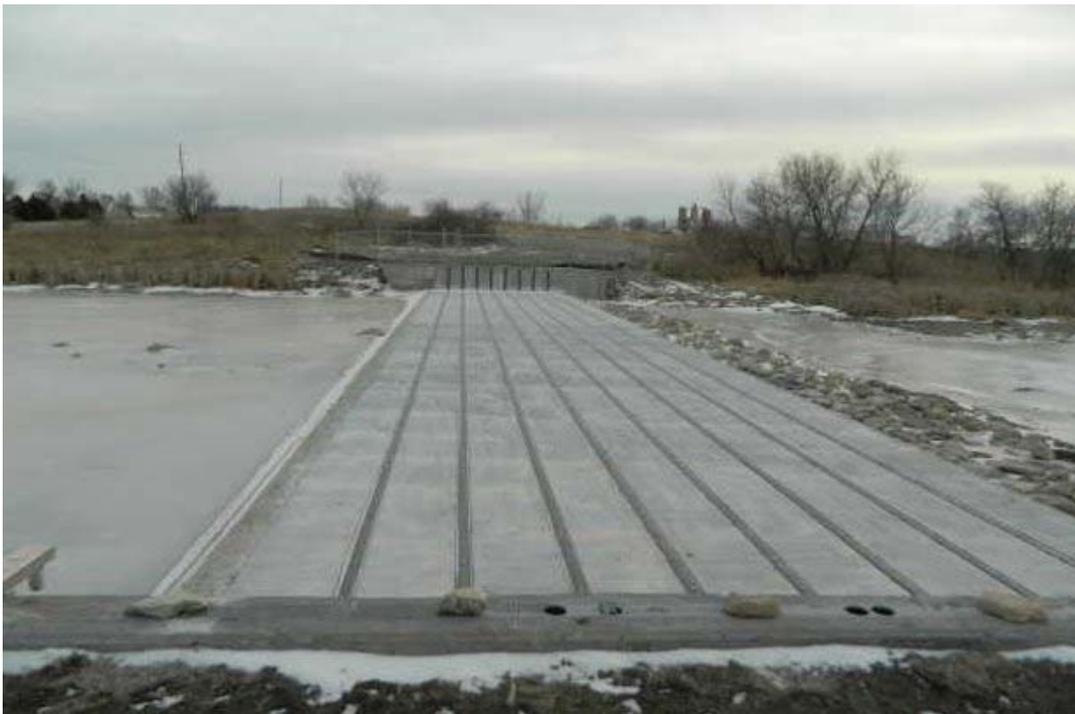
Figure 3 – Electric Strip Barrier

In this alternative, an electric strip will be placed on the spillway and could prevent fish approaching the spillway to a desired radius. This alternative requires supplied power to the electric strips. In this alternative, walkway and security fence is not necessary, but could be included in design. This alternative has advantages and disadvantages shown below. An example of an electric strip barrier can be seen below in Figure 3.

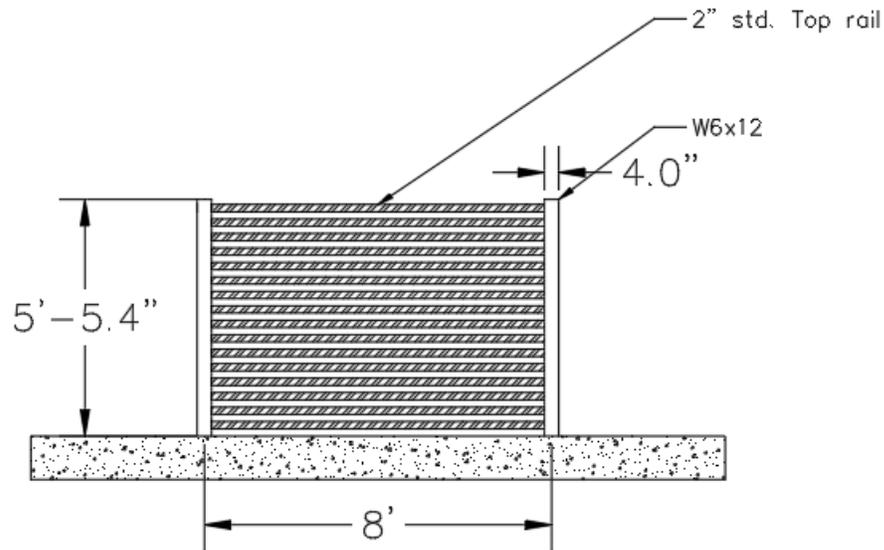
Figure 4 Typical Fence Section

Horizontal members will have 2" vertical spacing to allow minimal water resistance while maintaining a spacing small enough to retain 1.5" to 2" sized fish. Typical fence section is displayed below in Figure 4.

Hydraulic analysis was performed for the design of this barrier to ensure the barrier could withstand a design storm event. The 100-year event estimate of 6,700 cfs of flow and 5.45 ft of water over the spillway has been considered for force on fence members. Horizontal fence members were designed as having tube geometry as opposed to square or angle geometry. The tube geometry offers structural integrity while having lower resistance to the flow of water. Horizontal members were designed to withstand hydraulic force during a 100-year event with some blockage from debris. For this reason, horizontal members will be made of 2-inch galvanized tubing, fastened to vertical members over a span of 8 feet. Horizontal members will be fastened with bolts designed to fail when the force on horizontal members becomes too great as result of blockage during high flow events. In these scenarios, the fastener will fail, the horizontal member will drop down to allow the debris to pass. When working conditions are safe, workers could lift the existing member back into place and fasten with a new bolt without the need to recover fence sections or members from the bottom of the spillway. Vertical members are designed to be constructed of W6 x 12 uprights, welded to a base plate that will be mounted to the peak of the spillway crest. Vertical members are designed with the assumption of a 100-year event with total blockage. This ensures the members are built to withstand a design event without failure. Hydraulic calculations are included in Appendix A: Calculations.

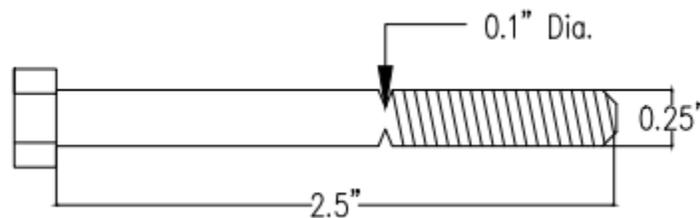
Figure 5 – Shear Pin Detail

Shear pin fasteners will be used for connecting horizontal members to the rigid upright members. During a scenario in which a barrier section is completely blocked, the fastener is designed to fail in tension, allowing the debris to pass. The shear pin is a typical $\frac{1}{4}$ inch stainless steel bolt with a notch cut into it by the manufacturer. The notch reduces the tension strength of the bolt to facilitate failure when blockage occurs. Once the shear pin fails, the horizontal member can fall on one side and allow the debris to pass. This design yields less maintenance, where a worker would simply access the structure, pick up one side of the horizontal member, and replace the bolt, without the need to retrieve the member from the bottom of the spillway or downstream in Bluff Creek. Typical shear pin detail can be seen below in Figure 5.

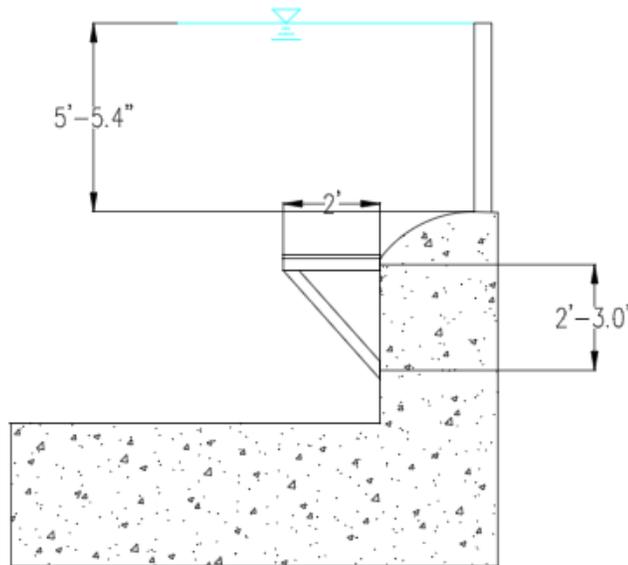
Figure 6 Typical Maintenance Walkway Detail

debris, or other maintenance work. The primary purpose of the maintenance walkway is to clear debris from the barrier as needed. For structural analysis of the maintenance walkway, two load scenarios were considered. The first scenario was without high water and with the weight of four workers on top of the barrier. The second scenario is during a high-water event, but without the weight of workers. The second scenario governed the design of the maintenance walkway structure. Force calculations for design of the maintenance walkway can be found in Appendix A. The gallery of the maintenance walkway will be constructed of L3 x 3 x 0.5 angle. The structure will be mounted with two bracing members welded to a base plate and fastened into the side of the existing spillway with stainless steel wedge anchors. The maintenance walkway grading is 1" galvanized serrated grading. Maintenance walkway detail is displayed below in Figure 6.

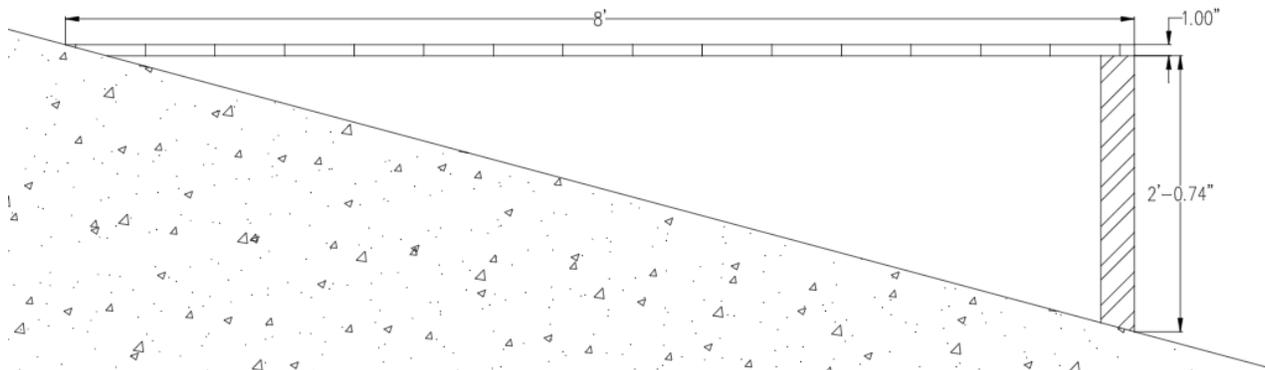
Figure 7 Lower Barrier Detail

Design of the lower barrier used the same load scenarios as the primary barrier maintenance walkway. The lower barrier gallery will be constructed of 3" steel angle, braced and mounted to the face of the spillway at design elevation. The barrier will consist of 1" galvanized serrated grading, similar to the maintenance walkway for the fence-type barrier. Lower barrier detail can be seen below in Figure 7.

To prevent the invasion of gizzard shad, a lower barrier is designed to be mounted on the face of the spillway. Similar to the upper barrier, the lower barrier is designed for a 100-year event. On the downstream side of the spillway, the 100-year event flood elevation is estimated at 1,062 ft elevation. This event elevation was estimated using a FEMA Floodplain map is provided in Appendix B.
